# Continued Monitoring of Stormwater Effluents from Filter Media in Two Bioslope Sites

**Meijun Cai, Principal Investigator**  
Natural Resources Research Institute  
University of Minnesota Duluth

**June 2021**

Research Project  
Final Report 2021-15

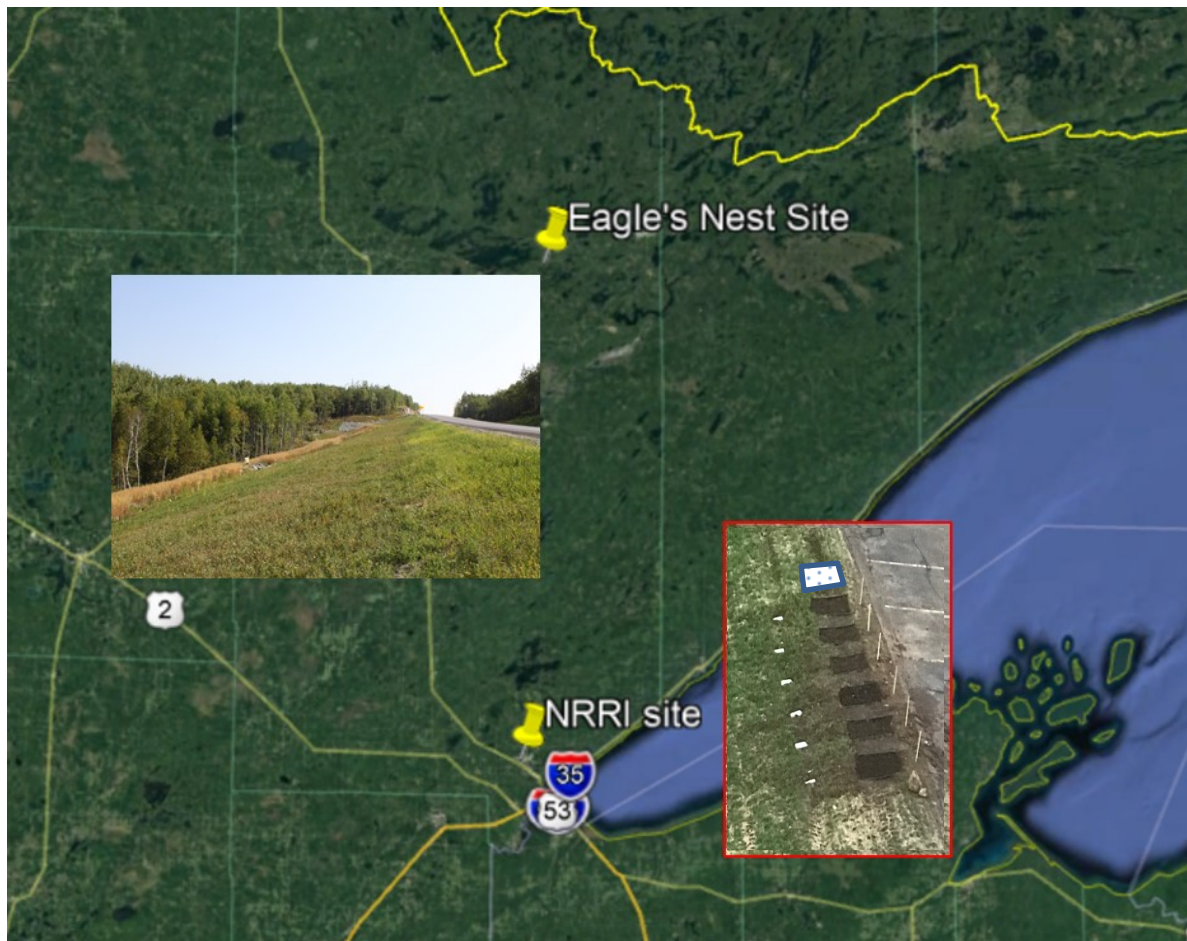
Figure 2.1 Two field sites in northeastern Minnesota.

Two field bioslope sites include one experimental site located in the NRRI parking lot and one roadside site (Eagle's Nest site) at Highway 169 reference (mile) post 270 close to Tower, MN (Figure 2.1).

In addition to the six experimental plots, another plot (the white plot in Figure 2.1) of the same size was constructed in 2018 using the mixture of compost and tailings (1:1), funded by University of Minnesota internal funding. The water quality data of this plot are included in this report to evaluate the pollutant removal efficiencies by different soil material blends.

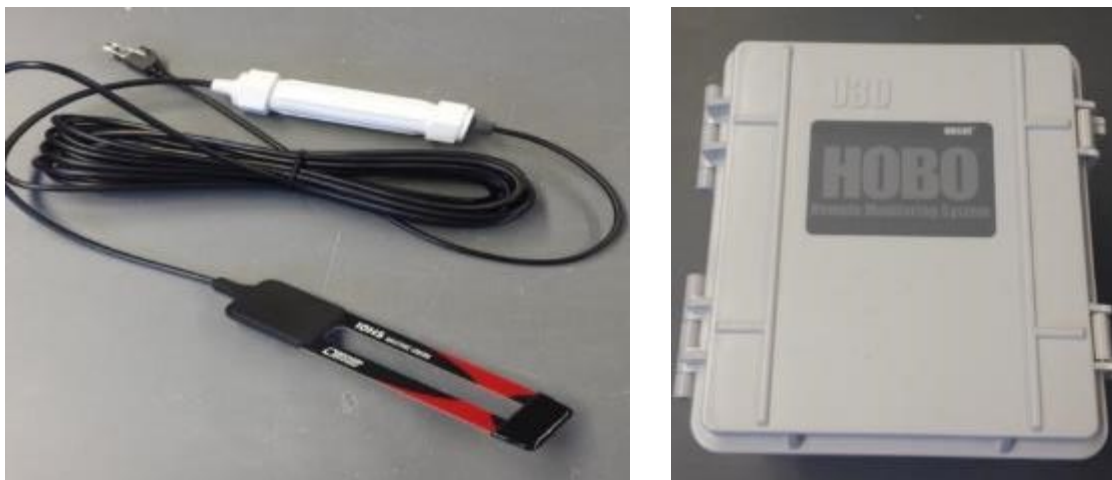
Figure 2.4 The moisture sensor (left) and data logger (right) used for in-situ moisture measurement.

Soil moisture changes were monitored by moisture sensors (Figure 2.4), which were connected to a data logger. The tip ends of the moisture sensors were inserted into soil at a depth around 9 cm. A solar panel was installed to provide a trickle charge for the 10 amp/hour battery and extend battery life.

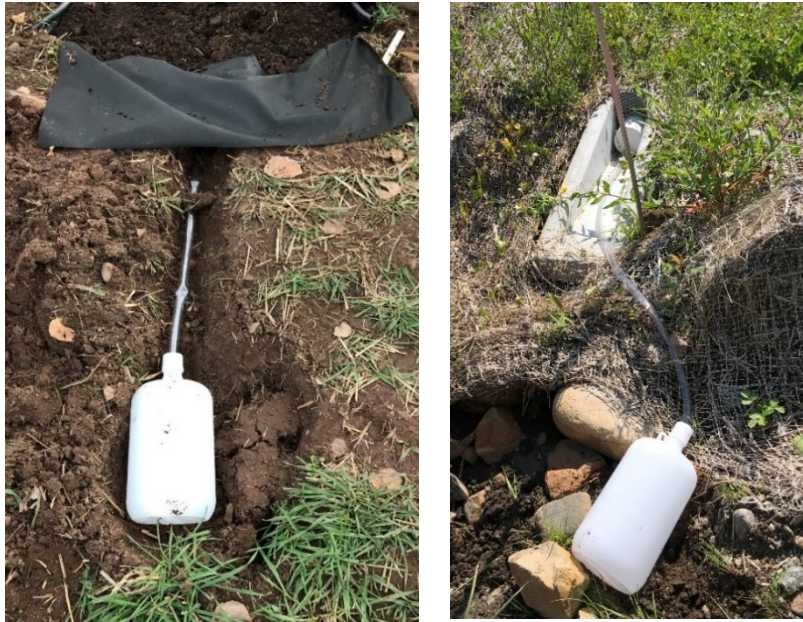
**Figure 2.6 Perforated pipe to collect water samples in the NRRI site (left) and Eagle's Nest trench site (right).**

Seven pipes to capture runoff were installed at the NRRI site and two were used at the Eagle's Nest trench (Figure 2.6). These pipes were installed when the experimental site was constructed in 2016 at the NRRI site and when Highway 169 was reconstructed in 2018. No additional construction was completed for this project. Water samples were collected from both the NRRI and Eagle's Nest sites by perforated pipe installed under modified soil media and are connected to the collectors.

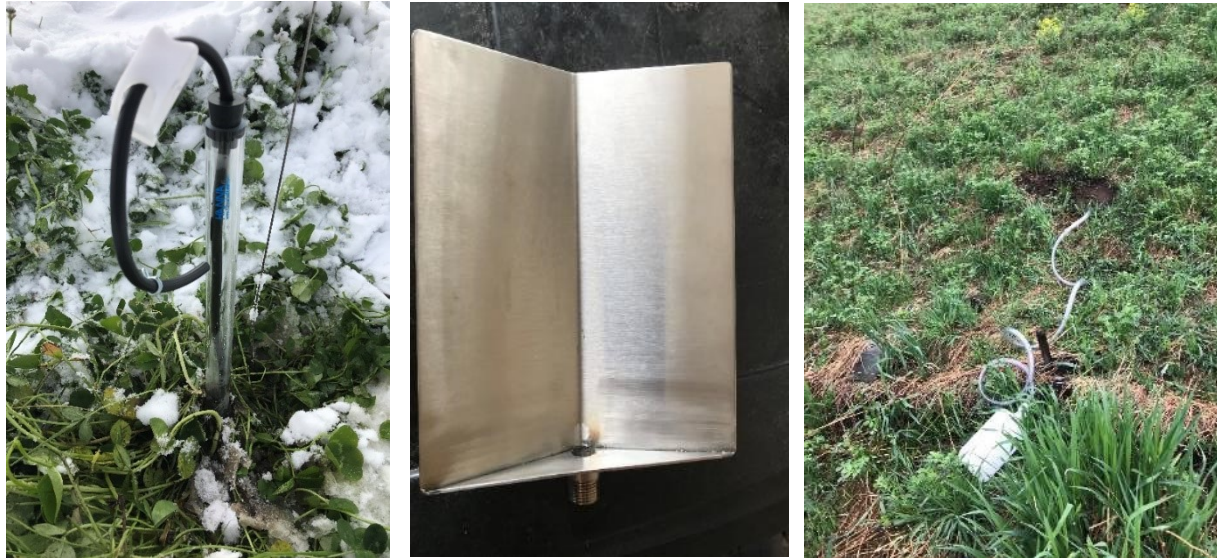
**Figure 2.7** The suction lysimeter (left) used in 2019 and the 1-ft pan lysimeter (middle and right) used in 2020 at the Eagle's Nest slope.

For the bioslope at the Eagle's Nest site, water samples were collected by six suction lysimeters, which were installed after spring snow melted and removed after the first fall snow in 2019 (Figure 2.7). In 2020, water samples were collected by a stainless pan lysimeters, which were newly manufactured this year because the suction lysimeters used in 2019 were damaged by grass mowing and animal activities.

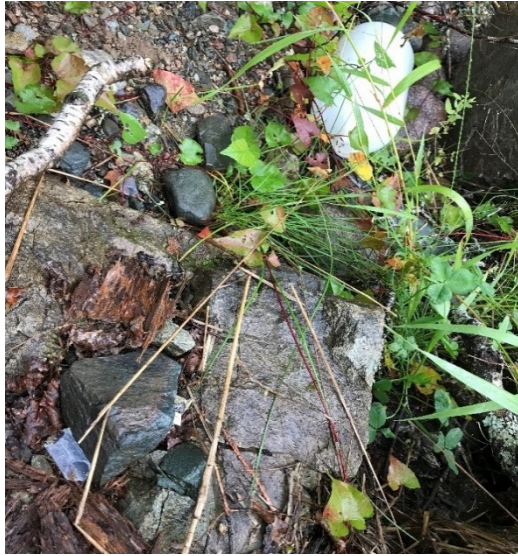
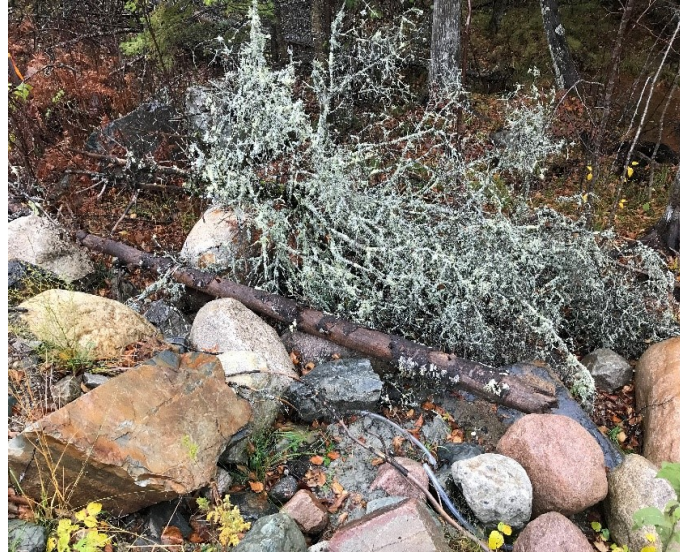
**Figure 2.8** The same trench water collection point. The picture on the left was taken on September 10, 2019. The tube connection to the sample collection bottle was cut, probably by an animal. The same site was destroyed by fallen trees, as shown in the picture on the right taken on October 22, 2019.

In 2019, some field monitoring equipment on the Eagle's Nest site became non-functional by natural or human activities. In September, one trench pipe outlet was observed to be cut, possibly by an animal's chewing (Figure 2.8). The sample collection jar was pushed away from the site. The tube was reconnected at that time. However, a fallen tree, together with some rock debris, buried that site in October. Now the entire site and its equipment are completely destroyed and covered by the fallen tree.

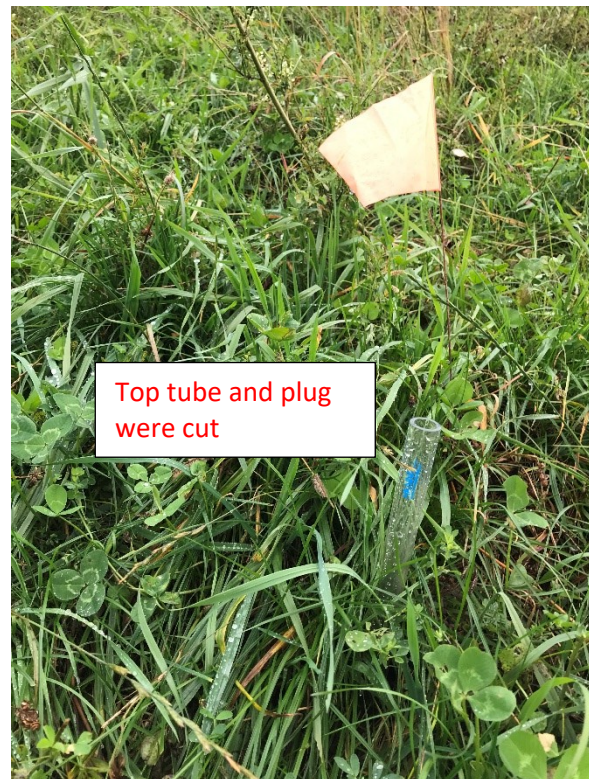
**Figure 2.9** Pictures of destroyed lysimeters taken on October 11, 2019. The picture of a working lysimeter is shown on the left in Figure 2.7.

All six lysimeters on the Eagle's Nest slope were destroyed between September 13 and October 11, 2019 (Figure 2.9). These lysimeters may have been cut by grass mowing. Therefore, no sample was collected from the slope after September 13 in 2019.
